AIRPROX REPORT No 2024139

Date: 21 Jun 2024 Time: 0907Z Position: 5147N 00035E Location: 2NM ENE of Boreham

PART A: SUMMARY OF INFORMATION REPORTED TO UKAB

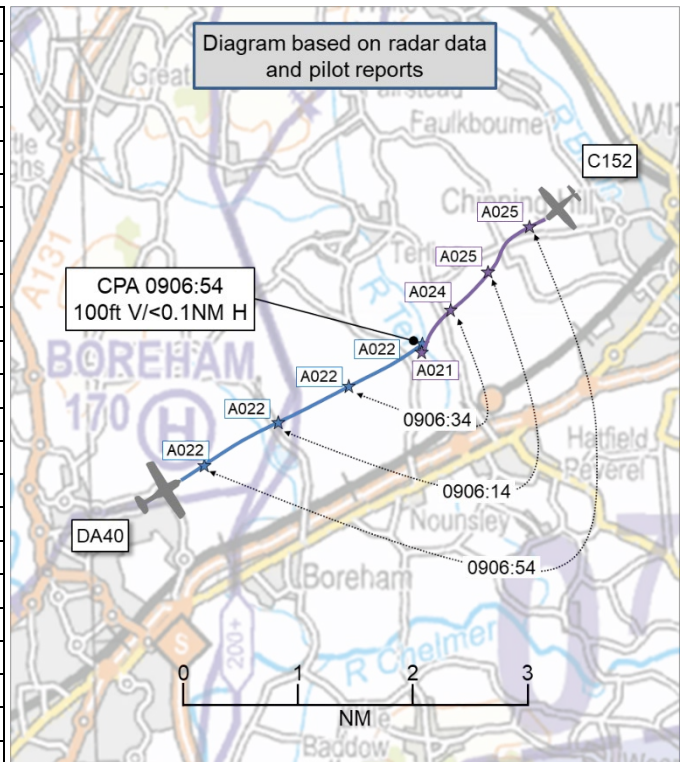
Recorded	Aircraft 1	Aircraft 2
Aircraft	DA40	C152
Operator	Civ FW	Civ FW
Airspace	London FIR	London FIR
Class	G	G
Rules	VFR	VFR
Service	Basic	Listening Out
Provider	Southend Radar	Southend Radar
Altitude/FL	2200ft	2100ft
Transponder	A, C, S	A, C, S
Reported		
Colours	White/blue decals	Green/White
Lighting	strobes	Nav, landing, bcn
Conditions	VMC	VMC
Visibility	>10km	>10km
Altitude/FL	2200ft	2000ft
Altimeter	QNH (1014hPa)	QNH
Heading	070°	225°
Speed	125kt	90kt
ACAS/TAS	PilotAware	Not fitted
Alert	Information	N/A
Separation at CPA		
Reported	50ft V/100m H	0ft V/50m H
Recorded	100ft V/<0.1NM H
