AIRPROX REPORT No 2024160

Date: 13 Jul 2024 Time: 1009Z Position: 5250N 00245W Location: Sleep Airfield

PART A: SUMMARY OF INFORMATION REPORTED TO UKAB

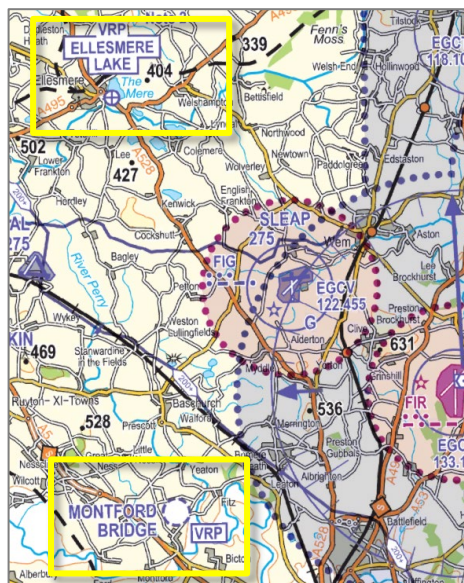
Figure 1: Local area 1:250,000 chart showing designated VRPs

THE SLEAP AGO reports that during the Sleapkosh fly in, RW23RH circuit had been in use, as per the join procedures for that day.^{1,2} Aircraft were to join into the downwind and overhead from the Montford Bridge VRP and Ellesmere Lake VRP respectively, which had been spaced well. The C182 had taken off earlier in the day and returned, joining the circuit flying inside other aircraft. The C182 pilot turned early into the final approach, well inside the established circuit traffic, which included the RV6 which had already been on final. The A/G operator suggested a go-around to the C182 pilot which they had then flown and rejoined the circuit.

¹ Issued Join Procedures (V2) stated: RW23LH/05RH. Joins from the south via the Montford Bridge VRP for an Overhead Join at 2000ft QFE. Joins from the north west via the Ellesmere Lake VRP for a Crosswind Join 1000ft QFE on 05RH or 23LH.
