**AIRPROX REPORT No 2024175**

Date: 24 Jul 2024 Time: 1533Z Position: 5407N 00320W Location: 3NM W Walney

**PART A: SUMMARY OF INFORMATION REPORTED TO UKAB**

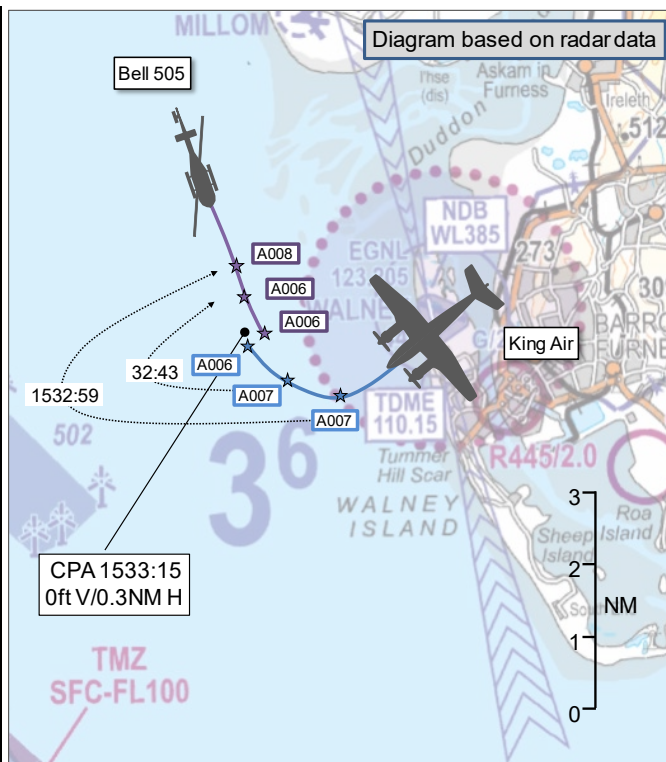
Recorded	Aircraft 1	Aircraft 2
Aircraft	King Air	Bell 505
Operator	Civ Comm	Civ Helo
Airspace	London FIR	London FIR
Class	G	G
Rules	VFR	VFR
Service	AFIS	Basic
Provider	Walney	Warton
Altitude/FL	600ft	600ft
Transponder	A, C, S+	A, C, S
<b>Reported</b>		
Colours	NK	Grey
Lighting	NK	Anti-col, Nav
Conditions	VMC	VMC
Visibility	NR	5-10km
Altitude/FL	NR	700ft
Altimeter	NK	QNH
Heading	NR	NK
Speed	NR	119kt
ACAS/TAS	TCAS II	Not fitted
Alert	Information	N/A
<b>Separation at CPA</b>		
Reported	NR	100ft V/500m H
Recorded	0ft V/0.3NM H
