AIRPROX REPORT No 2024180

Date: 01 Aug 2024 Time: 1350Z Position: 5107N 00104E Location: Pent Farm

PART A: SUMMARY OF INFORMATION REPORTED TO UKAB

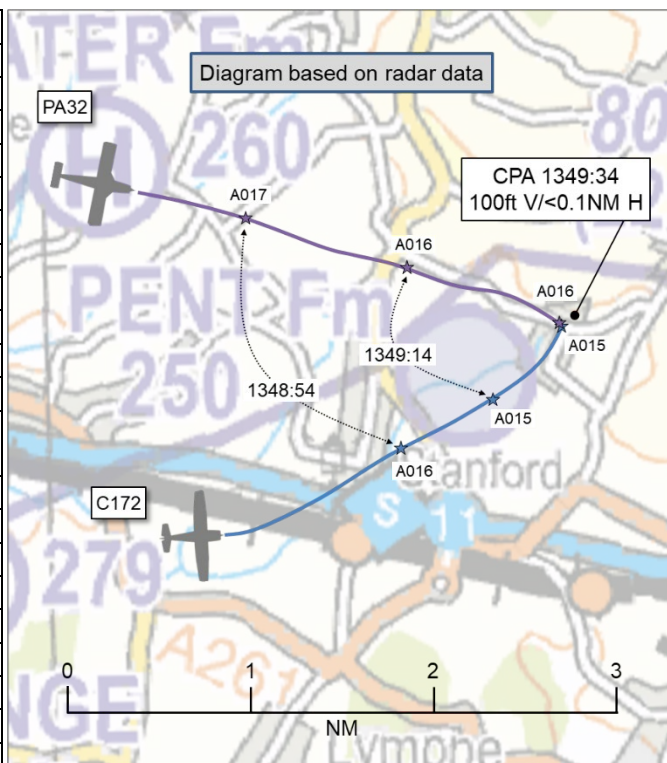
Recorded	Aircraft 1	Aircraft 2
Aircraft	C172	PA32
Operator	Civ FW	Civ Comm
Airspace	London FIR	London FIR
Class	G	G
Rules	VFR	VFR
Service	Listening Out	Basic
Provider	SafetyCom	Lydd
Altitude/FL	1500ft	1600ft
Transponder	A, C, S	A, C, S
Reported		
Colours	White	White
Lighting	Beacon	Strobes, nav, landing
Conditions	VMC	VMC
Visibility	5-10km	5-10km
Altitude/FL	1500ft	1800ft
Altimeter	QNH (1012hPa)	QNH
Heading	070°	100°
Speed	100kt	135kt
ACAS/TAS	Not fitted	SkyEcho
Alert	N/A	None
Separation at CPA		
Reported	50ft V/0m H	"not seen"
Recorded	100ft V/<0.1NM H
