AIRPROX REPORT No 2024214

Date: 17 Aug 2024 Time: ~1030Z Position: 5058N 00211W Location: Compton Abbas

PART A: SUMMARY OF INFORMATION REPORTED TO UKAB

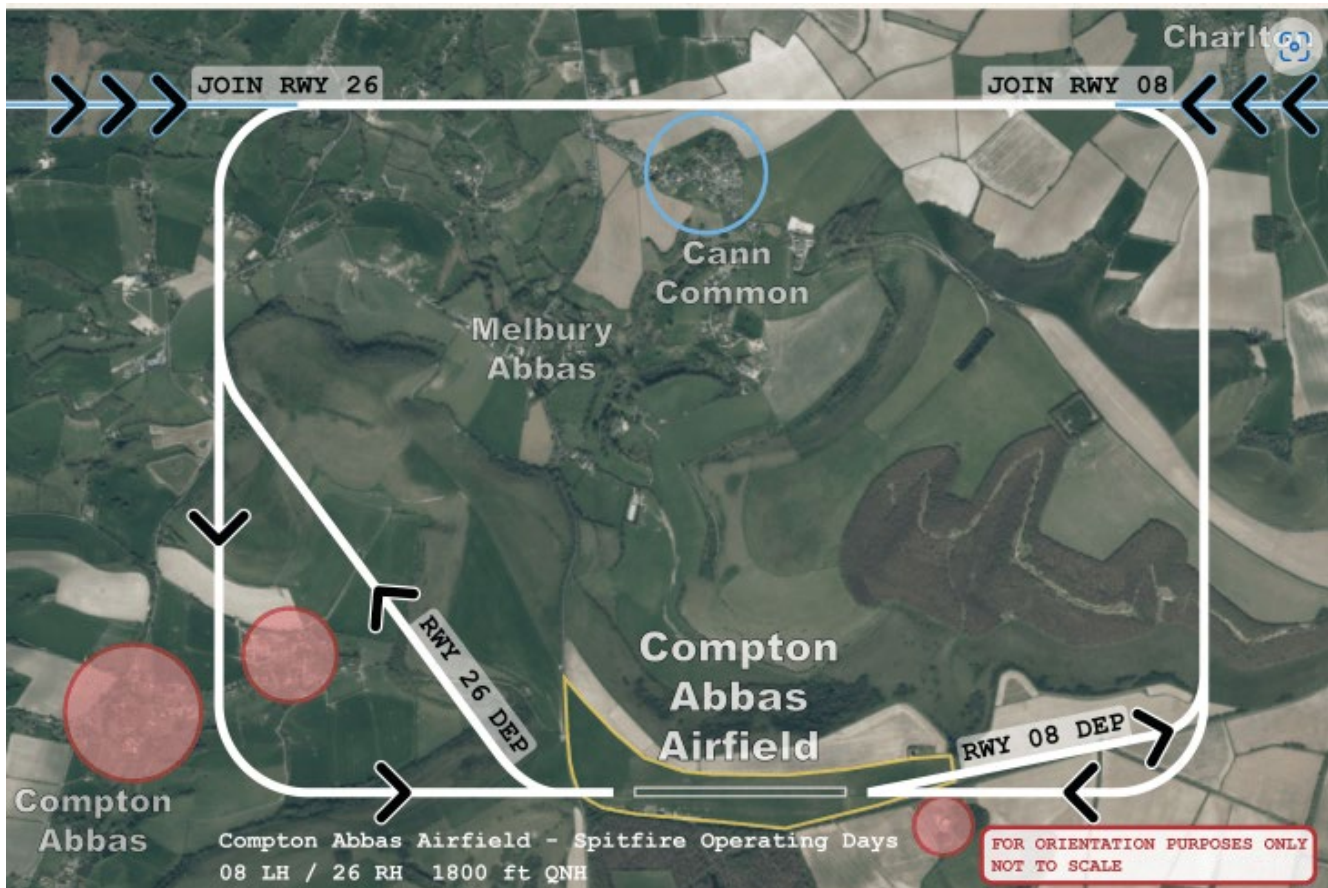
Figure 1 – Compton Abbas circuit procedures relevant to the day.

“During NOTAM d days of Spitfire Operations, the standard overhead join and deadside will not be in use. A downwind join must be used instead. This is to ensure these areas are kept sterile exclusively for the Spitfire.

Please plan your airfield arrival to join on ‘extended downwind’, at the circuit altitude of 1800’ QNH, as shown by blue arrows in the diagram above.

The downwind leg is flown as usual, please keep the aircraft to the North of ‘Cann Common’, marked with a blue circle on the diagram
