**AIRPROX REPORT No 2024215**

Date: 16 Aug 2024 Time: ~1607Z Position: 5332N 00023W Location: IVO Humberside Airport

**PART A: SUMMARY OF INFORMATION REPORTED TO UKAB**

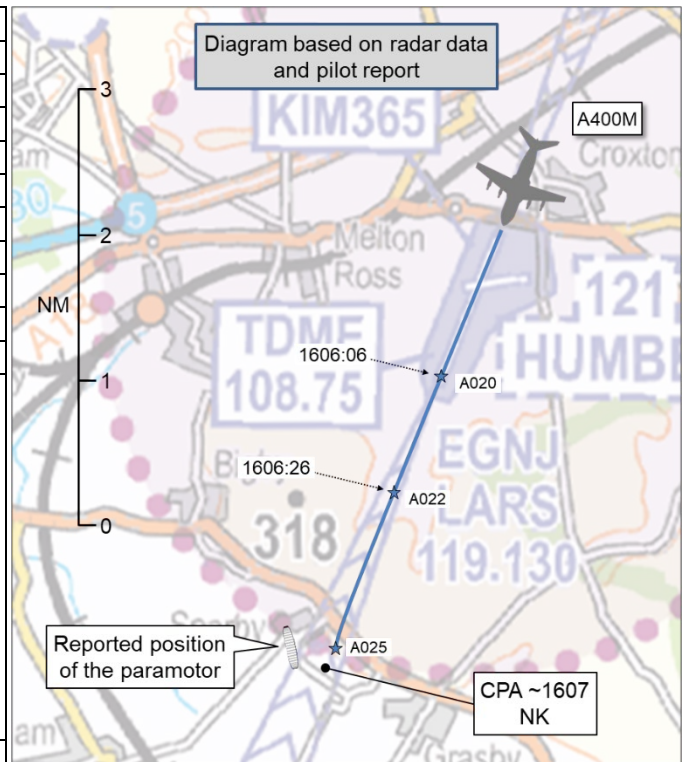
**THE A400M PILOT** reports that they had just conducted the second of two practice approaches at Humberside Airport. They were executing a planned go-around after the approach, and were cleared for own navigation to the south, climbing to FL60. As the aircraft passed through 2500ft AMSL, the Pilot Monitoring in the right-hand seat called visual on a paramotor in the 12 to 1 o'clock position, above and on a reciprocal course. The Pilot Flying immediately sighted the paramotor, disengaged the autopilot and turned left onto approximately 160° and continued the climb away from the paramotor to avoid a conflict. The traffic was reported to Humberside Radar [as a "paraglider"], who reported no radar contacts in the vicinity. Had avoiding action not been taken, it is estimated that they would have been co-altitude with the paramotor with less than 0.5NM separation.

An analysis of the NATS radar replay was undertaken. The A400M could be identified from Mode S data (Figure 3). The paramotor was not observed. The diagram was constructed from the radar data and the position of the paramotor has been shown as reported by the pilot of the A400M. The separation at CPA could not be determined.
