AIRPROX REPORT No 2019028

Date: 15 Feb 2019 Time: 1525Z Position: 5107N 00039E Location: 2nm south Headcorn

PART A: SUMMARY OF INFORMATION REPORTED TO UKAB

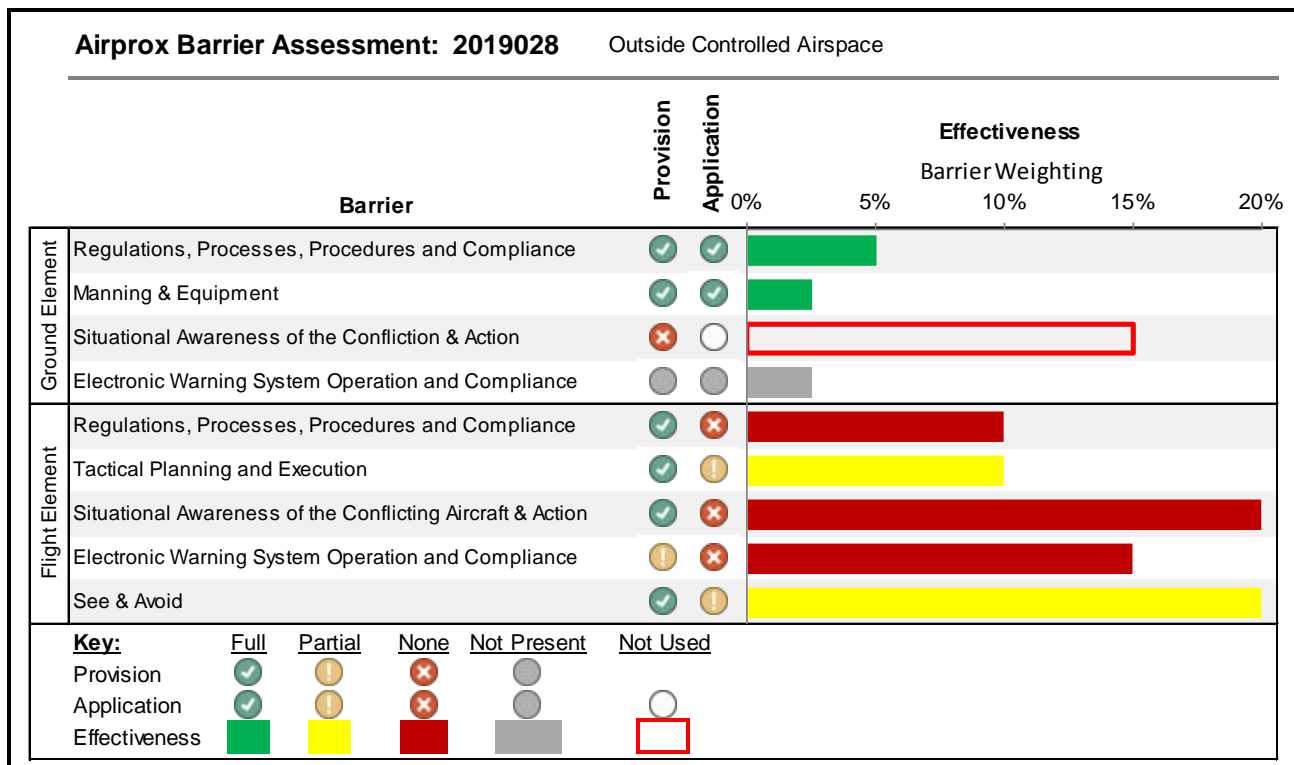
Safety Barrier Assessment³

In assessing the effectiveness of the safety barriers associated with this incident, the Board concluded that the key factors had been that:

Situational Awareness of the Conflication and Action were assessed as **not used** because neither pilot was in receipt of a FIS that would provide SA.

Regulations, Processes, Procedures and Compliance were assessed as **ineffective** because the BE36 pilot did not give way sufficiently to the P68 converging on his right.

Tactical Planning and Execution was assessed as **partially effective** because neither pilot requested a surveillance based FIS.

Situational Awareness of the Conflicting Aircraft and Action were assessed as **ineffective** because the BE36 pilot continued into conflict despite having TAS-based SA at range.

Electronic Warning System Operation and Compliance were assessed as **ineffective** because the separation at CPA was such that the Board surmised that the BE36 pilot had not acted sufficiently on his TAS warnings.

See and Avoid were assessed as **partially effective** because the BE36 pilot closed to 100ft vertical and 0.1nm lateral separation from the P68, despite having seen it at range.
