AIRPROX REPORT No 2019142

Date: 06 Jun 2019 Time: 1232Z Position: 5220N 00057E Location: 17NM E Mildenhall

PART A: SUMMARY OF INFORMATION REPORTED TO UKAB

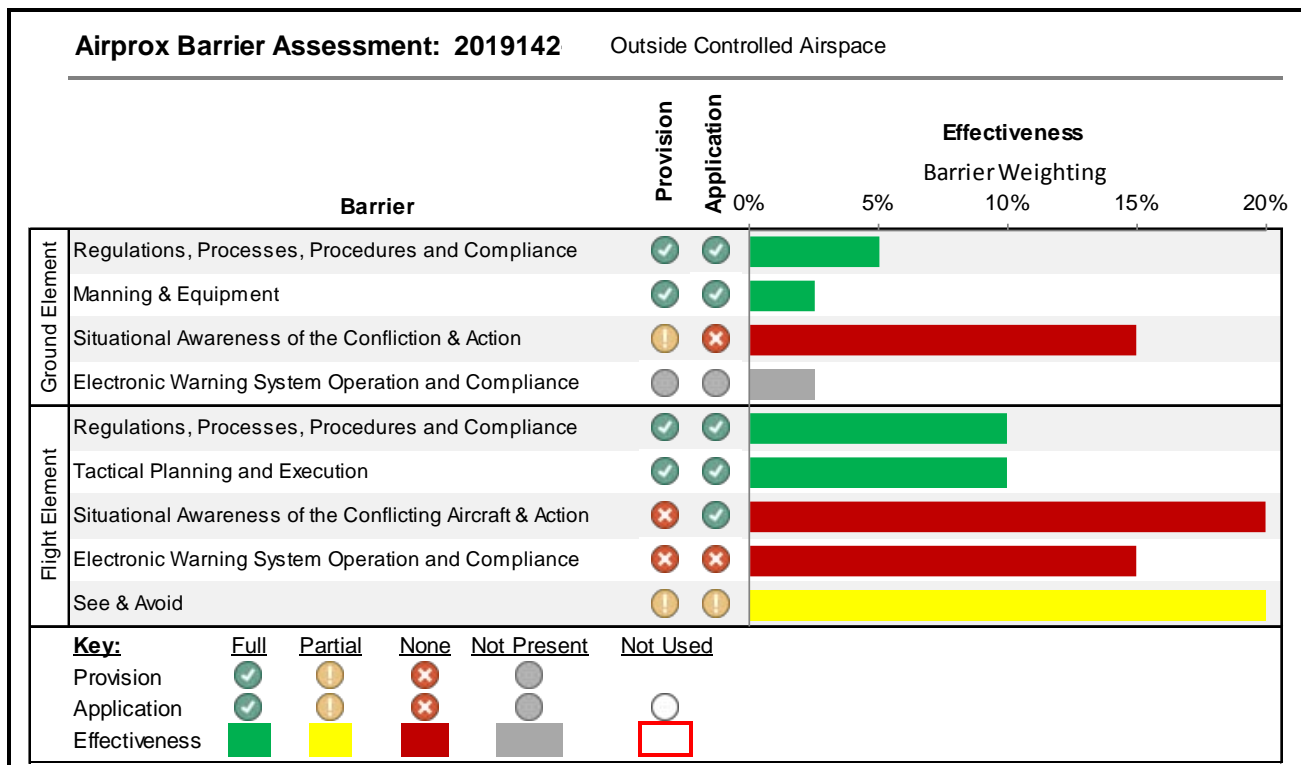
Safety Barrier Assessment³

In assessing the effectiveness of the safety barriers associated with this incident, the Board concluded that the key factors had been that:

Ground Elements:

Situational Awareness of the Confliction and Action were assessed as **ineffective** because the Lakenheath controller did not detect the DG400.

Flight Elements:

Situational Awareness of the Conflicting Aircraft and Action were assessed as **ineffective** because the RC135 crew were not aware of the proximity of the DG400 and therefore could not give way or take avoiding action before CPA.

Electronic Warning System Operation and Compliance were assessed as **ineffective** because neither aircraft's traffic alerting system was compatible with the other aircraft.

See and Avoid were assessed as **partially effective** because the DG400 pilot saw the RC135, albeit at a late stage, and took avoiding action.
