AIRPROX REPORT No 2019164

Date: 27 Jun 2019 Time: 1334Z Position: 5736N 00319W Location: 1NM NNW Easterton gliding site

PART A: SUMMARY OF INFORMATION REPORTED TO UKAB

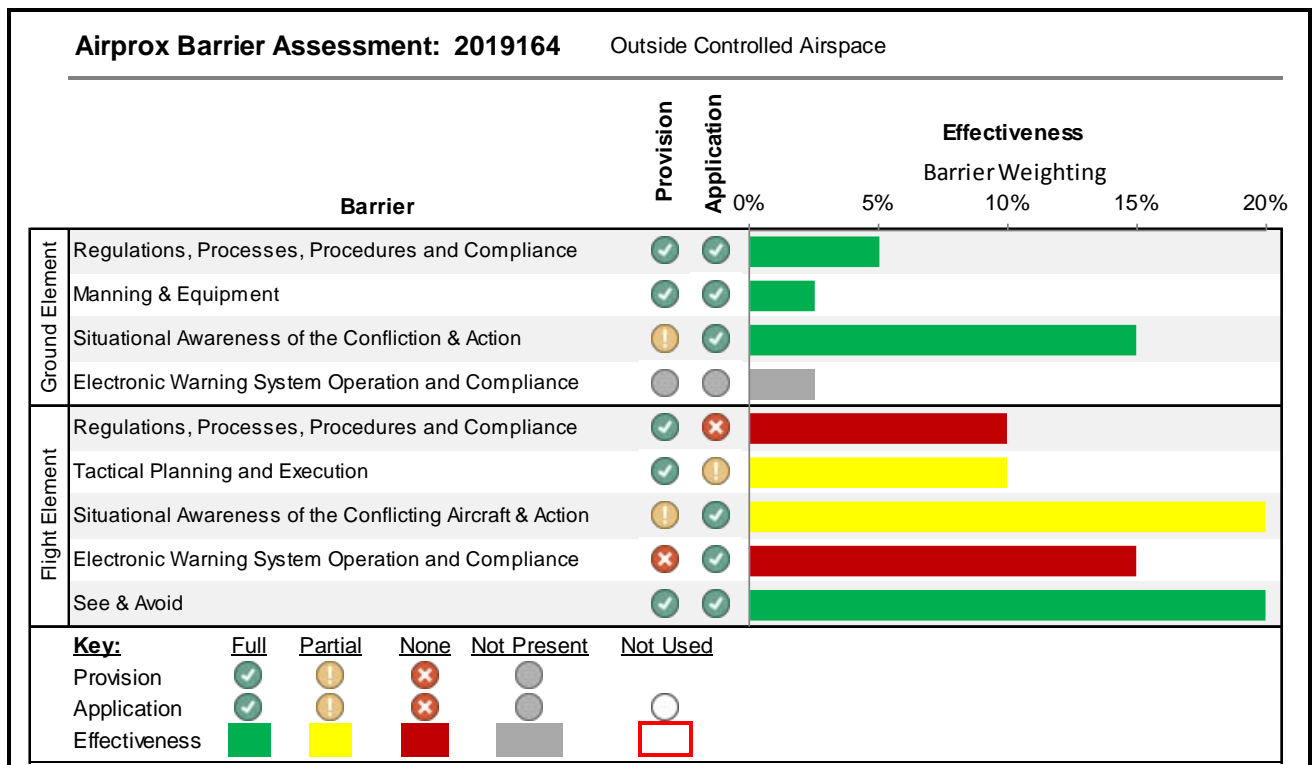
⁵ The UK Airprox Board scheme for assessing the Availability, Functionality and Effectiveness of safety barriers can be found on the [UKAB Website](#).

Electronic Warning System Operation and Compliance were assessed as **ineffective** because Typhoon is not fitted with a TAS and the Typhoon transponder was not compatible with the Duo Discus FLARM.
