**AIRPROX REPORT No 2016083**

Date: 20 May 2016 Time: 1145Z Position: 5228N 00015W Location: Conington

**PART A: SUMMARY OF INFORMATION REPORTED TO UKAB**

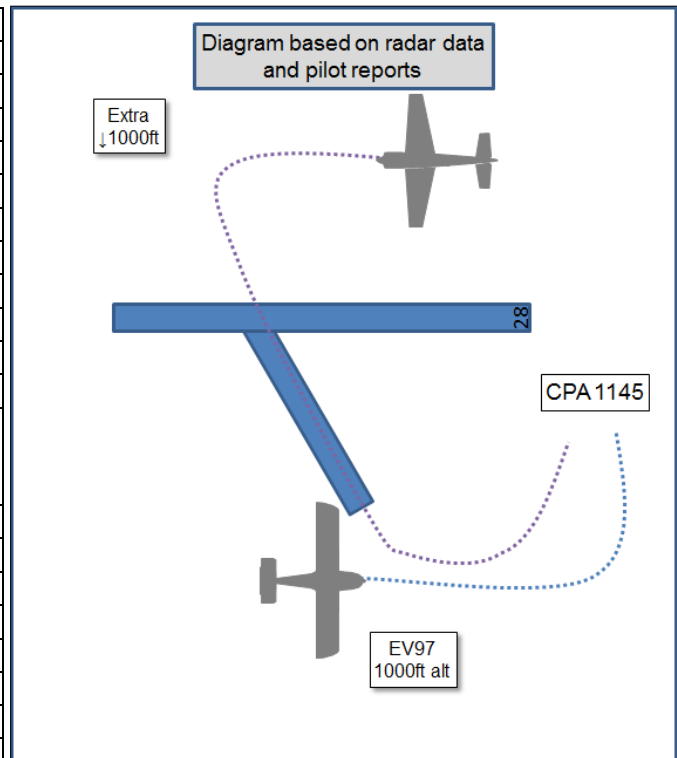
Recorded	Aircraft 1	Aircraft 2
Aircraft	EV97	Extra 200
Operator	Civ Trg	Civ Pte
Airspace	Conington ATZ	Conington ATZ
Class	G	G
Rules	VFR	VFR
Service	AGCS	AGCS
Provider	Conington	Conington
Altitude/FL	NK	NK
Transponder	A,C,S	A,C,S
Reported		
Colours	Silver, Blue	Blue, White
Lighting	Landing, Wingtip, Nav, Strobes	Strobes, Nav
Conditions	VMC	VMC
Visibility	10km	10km
Altitude/FL	1000ft	1000ft
Altimeter	QFE (1011hPa)	QFE
Heading	100°	100°
Speed	78kt	90kt
ACAS/TAS	Not fitted	Not fitted
Separation		
Reported	100ft V/0m H	Not Seen
Recorded	NK
