AIRPROX REPORT No 2016116

Date: 17 Apr 2016 Time: 1400Z Position: 5246N 00247W Location: 2nm SE Sleaf

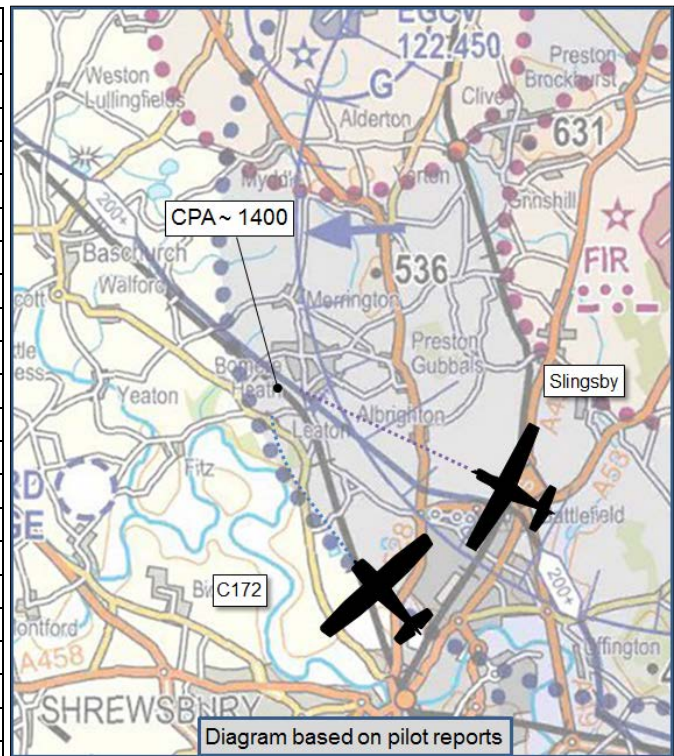
THE C172 PILOT reports that he was approaching Sleaf from the SE; he 'informed' Sleaf that he would turn and approach direct into deadside descending, which was acknowledged on the radio by the AGCS. He turned onto a heading of 350° at approximately 2nm from Sleaf and was descending from 2500ft. Within moments, a yellow Slingsby flashed in front of him descending at speed from the top-right side of the canopy at a distance of approximately 200m and away to the lower-left side out of sight. It took him by surprise because there had been no report of aerobatics over the airfield when he called up: he assumed the Slingsby was on an aerobatic training or practice detail. He completed a circuit and landed, after which he spoke to the Pilot of the Slingsby who had also landed at Sleaf. The Slingsby pilot said he had not seen the C172 nor had he heard them on the radio. He believes the situation was in part caused by the Slingsby being higher and behind his high-winged aircraft, and he being below the low-winged Slingsby as it was banking down. He did not know if the Slingsby was also entering deadside or crossing the airfield at 2000ft. Having discussed the matter an Airprox was not filed at the time, but was now being filed at the request of the Sleaf Head of Training.
