AIRPROX REPORT No 2012002

Date/Time: 8 Jan 2012 1403Z (Sunday)

Position: 5143N 00009E (RW20 North Weald - elev 321ft)

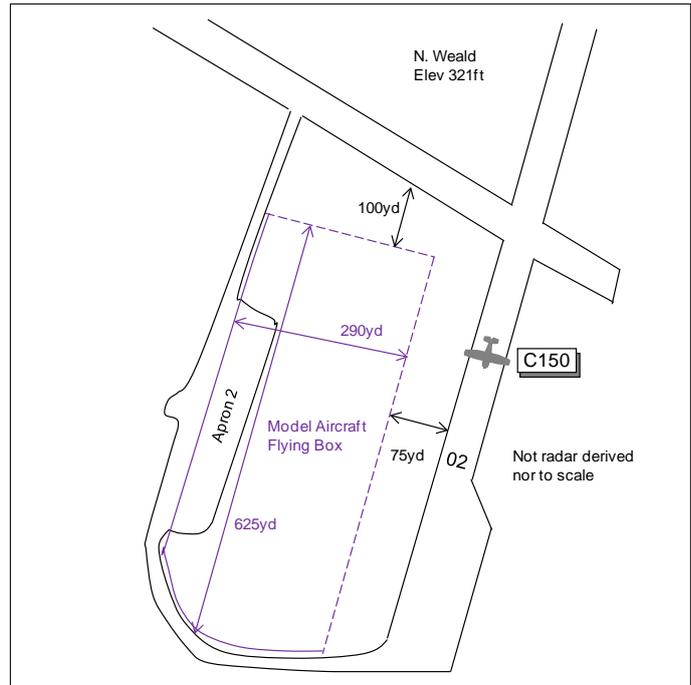
THE MODEL A/C OPERATOR reports flying an 88in wingspan model YAK54 between 1400 and 1515hr but did not recall at any point being in conflict with a C150. Throughout his flights he had adhered to the 'model flying box' at N Weald; the 'box' is limited airspace that is strictly policed by both his own club members and the ground control at the airfield. He was not made aware that rules on this or any other matter had been breached. To offer a safe system of operations, the Model Flying Club (MFC), airfield ATC and Operations use a ground to ground radio system that is manned at all times during their flying sessions. An aerial photo of N Weald with the Flying Box superimposed was provided as well as the flight pattern flown.

UKAB Note (1): The AIDU Minor Aerodromes and Microlight Sites publication also shows that model ac fly from an apron to the W of RW02 threshold. Local Hazards include model flying on the A/D during daylight hours.
